CHAPTER 8

Geologic Hazards: Risks and Mitigation

8.1 Identifying and Profiling Geological Hazards

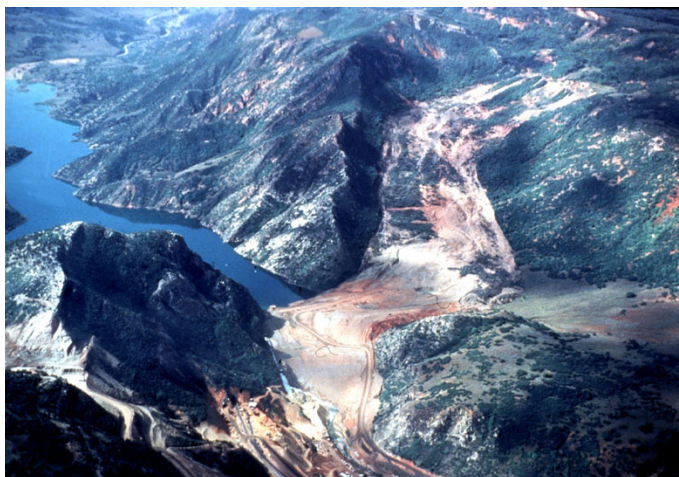
Aerial view of the 1983 Thistle landslide. Courtesy UGS

In 1983, the town of Thistle was destroyed by floodwaters when the Thistle landslide created a natural dam and subsequent reservoir, blocking roads and rail lines. The Marysvale branch of the Denver and Rio Grande Railroad was never reopened, leaving a large area of central Utah without rail service. Thistle resulted in Utah's first presidential disaster declaration and became the costliest landslide in U.S. history. Three reports have been issued estimating the cost of the landslide between \$200 and \$337 million dollars (1983 dollars).

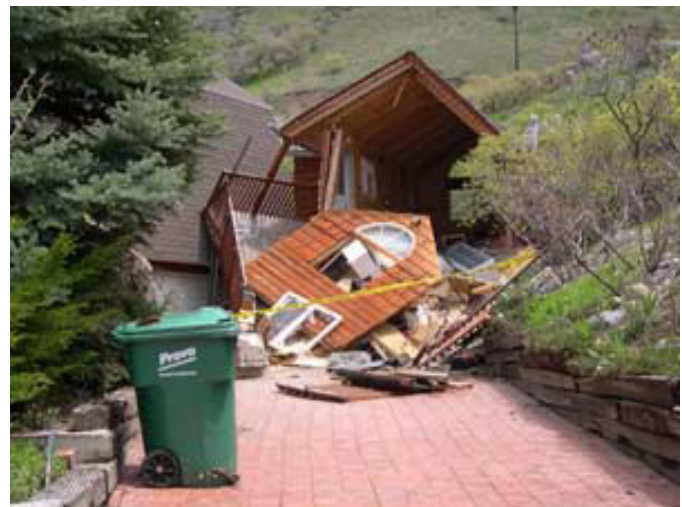
Damage from the 2005 Provo rockfall. Courtesy UGS

On May 12, 2005, at 5:00 p.m. a rockfall destroyed a guest house located in Provo. No fatalities resulted from the rockfall. The rock measured 7 feet by 5.1 feet by 4.5 feet and weighed approximately 13 tons. The rockfall is believed to have resulted from a series of significant storms that passed through the Provo area between May 10-12, in which approximately 3.7 inches of mixed rain and snow fell on the area. It was raining at the time of the rock fall.¹³

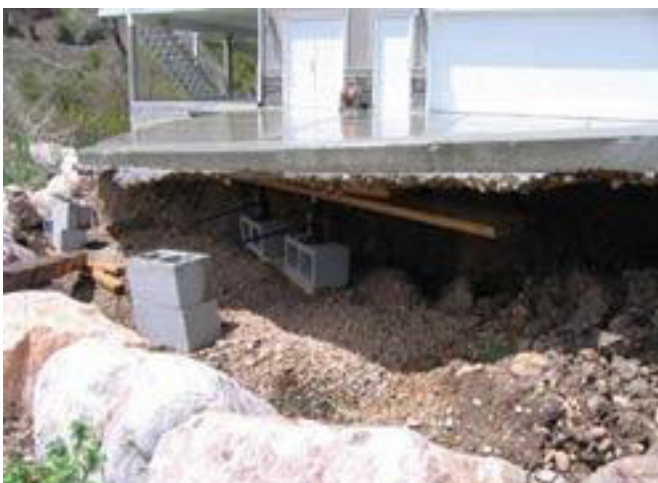
Landslide movement left this concrete driveway slab suspended in the air in the Creekside Drive area of Mountain Green. Courtesy UGS.

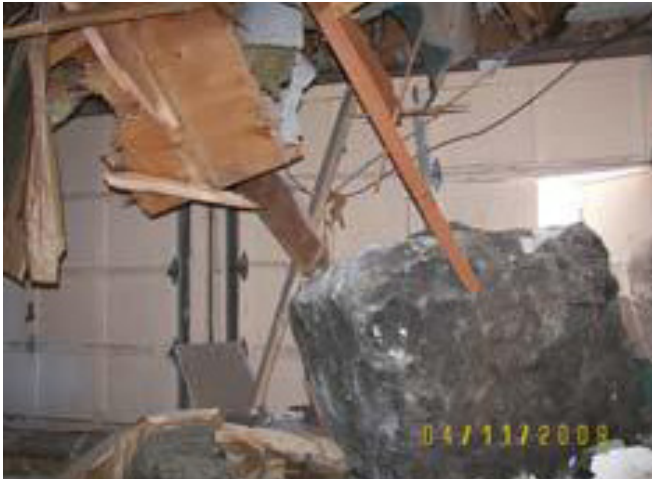
Boulder that damaged the vacant house at 1496 North 1550 East, Provo. Boulder is estimated to be 4 feet by 5 feet by 4 feet. Courtesy of the Provo Fire Department.

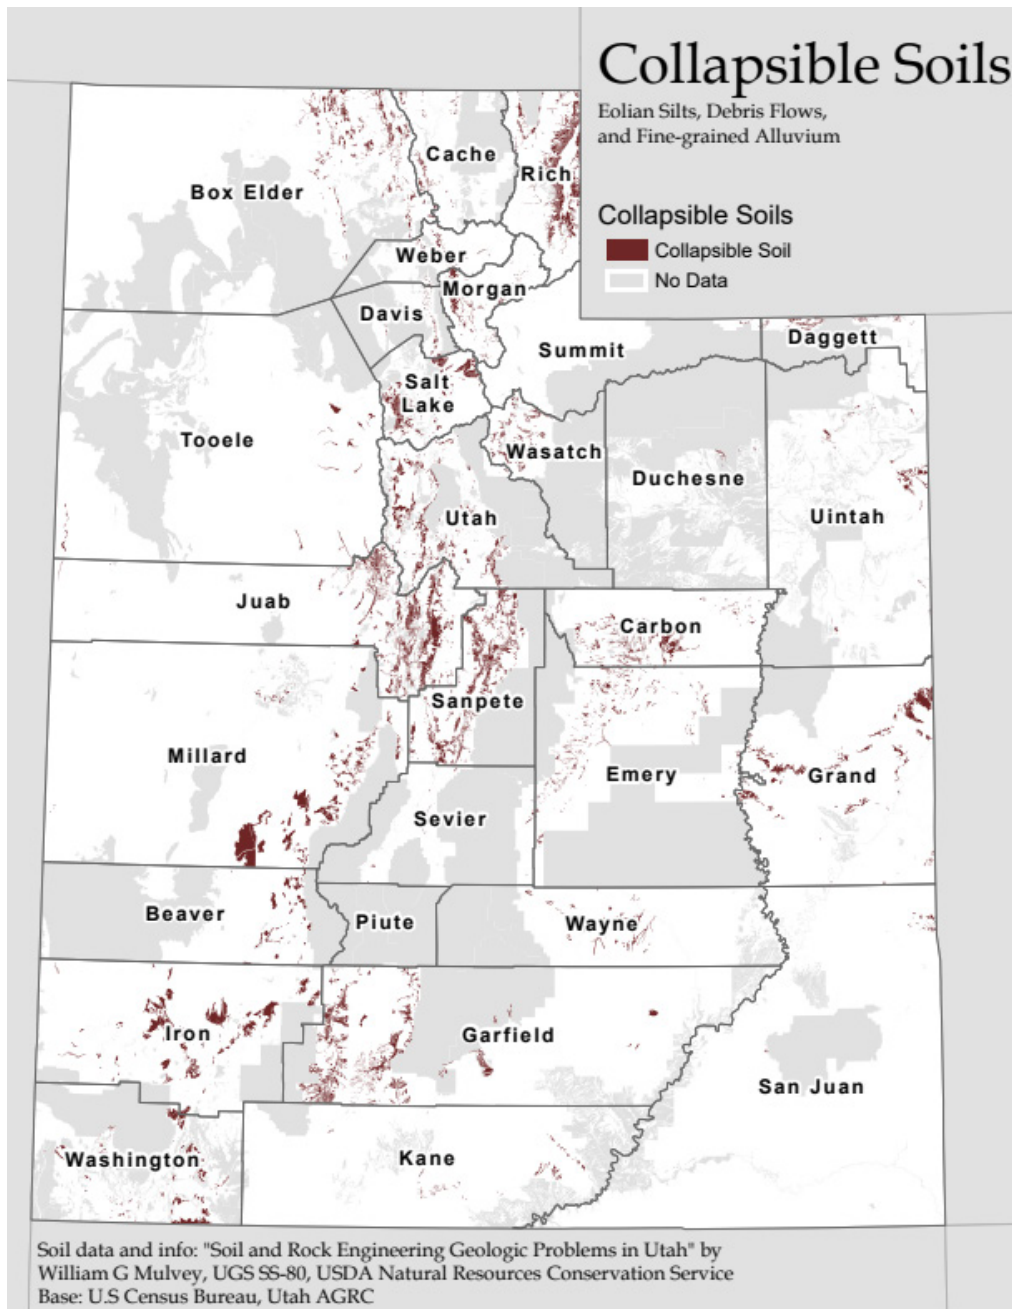
Map 9. Collapsible Soils

Collapsible soils are those soils that have considerable strength when in their dry, natural state, but that significantly settle due to hydrocompaction when wetted. They are typically associated with young alluvial fans, debris flows, and loess. These soils can cause asphalt concrete (AC) and Portland cement concrete (PCC) pavement failure, severe building and infrastructure distress and differential movement, and canals and other gravity flow utilities to fail.

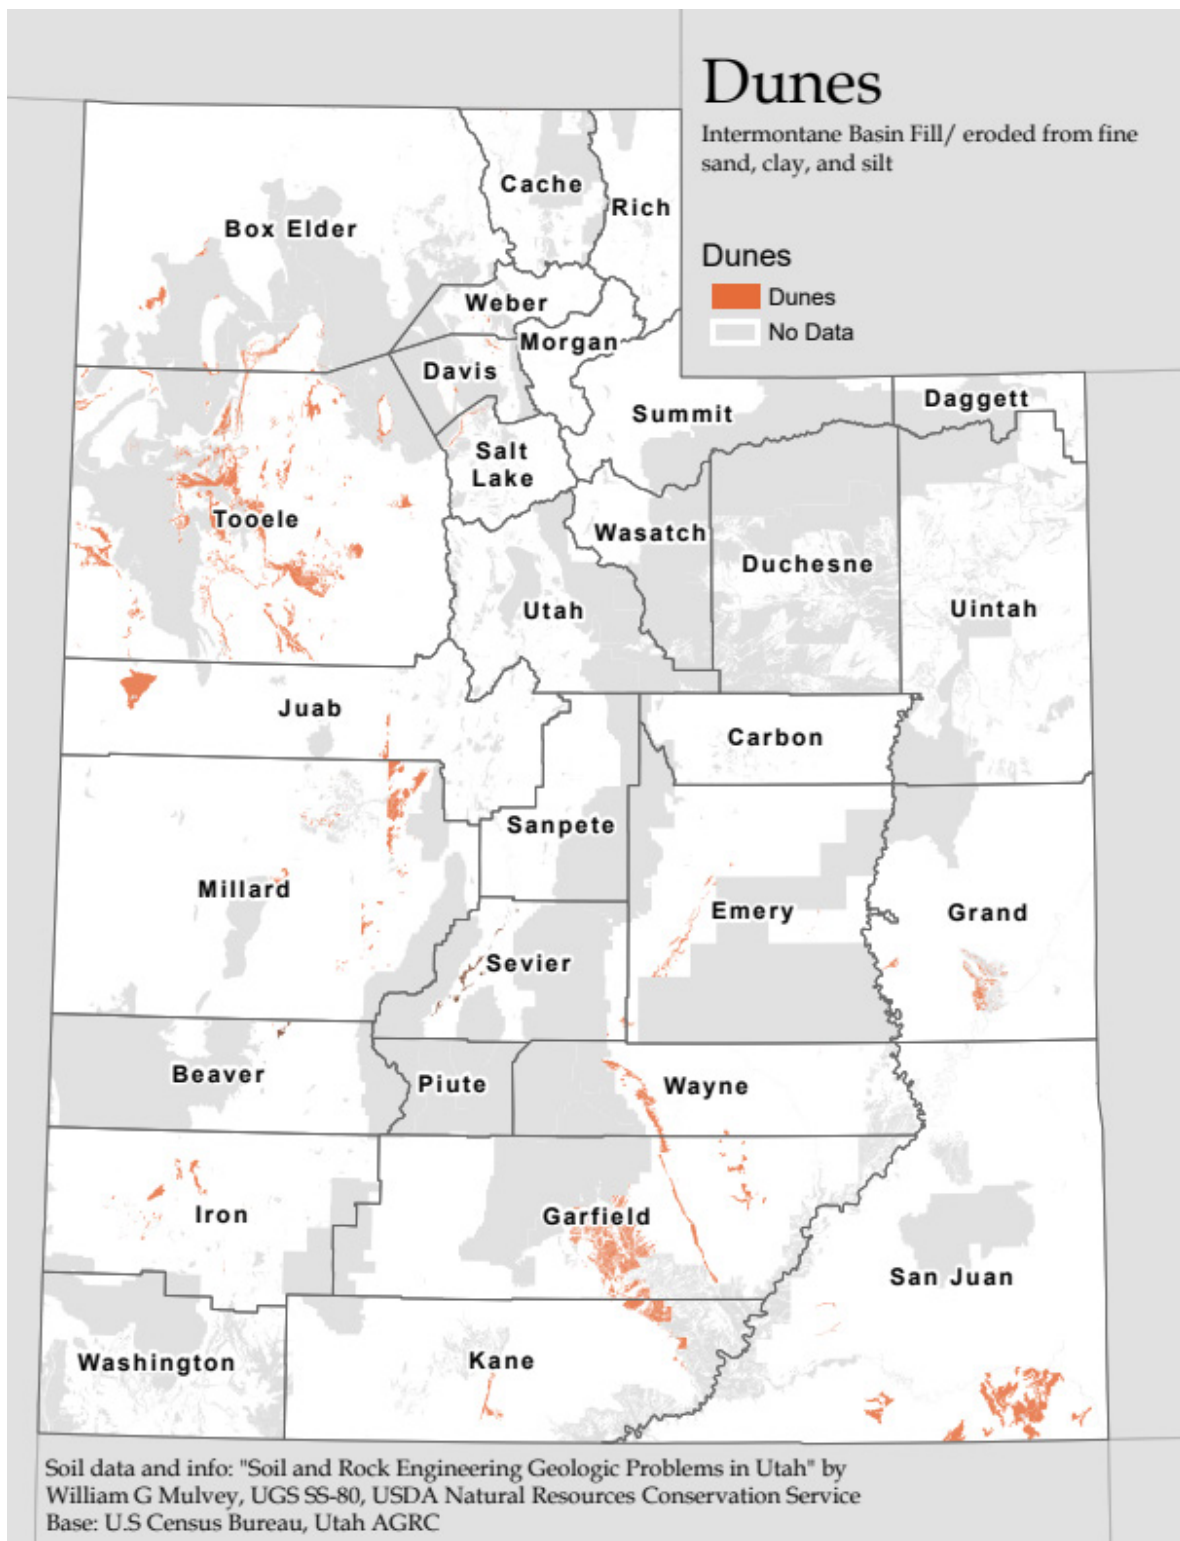
Map 13. Dunes

Geologically young, active or partially stabilized, wind-blown or mixed-unit sand deposits characterized by well-sorted, loose, sandy soil texture with few or no fines. Where disturbed, sandy soils may migrate across roads and bury structures, and wind erosion may expose foundations and underground utilities, along with being an inhalation health hazard.
